MERRIMACK RIVER BASIN
MANCHESTER, NEW HAMPSHIRE

MASSABESIC LAKE DAM
NH 00103

PHASE I INSPECTION REPORT
NATIONAL DAM INSPECTION PROGRAM

AUGUST 1978

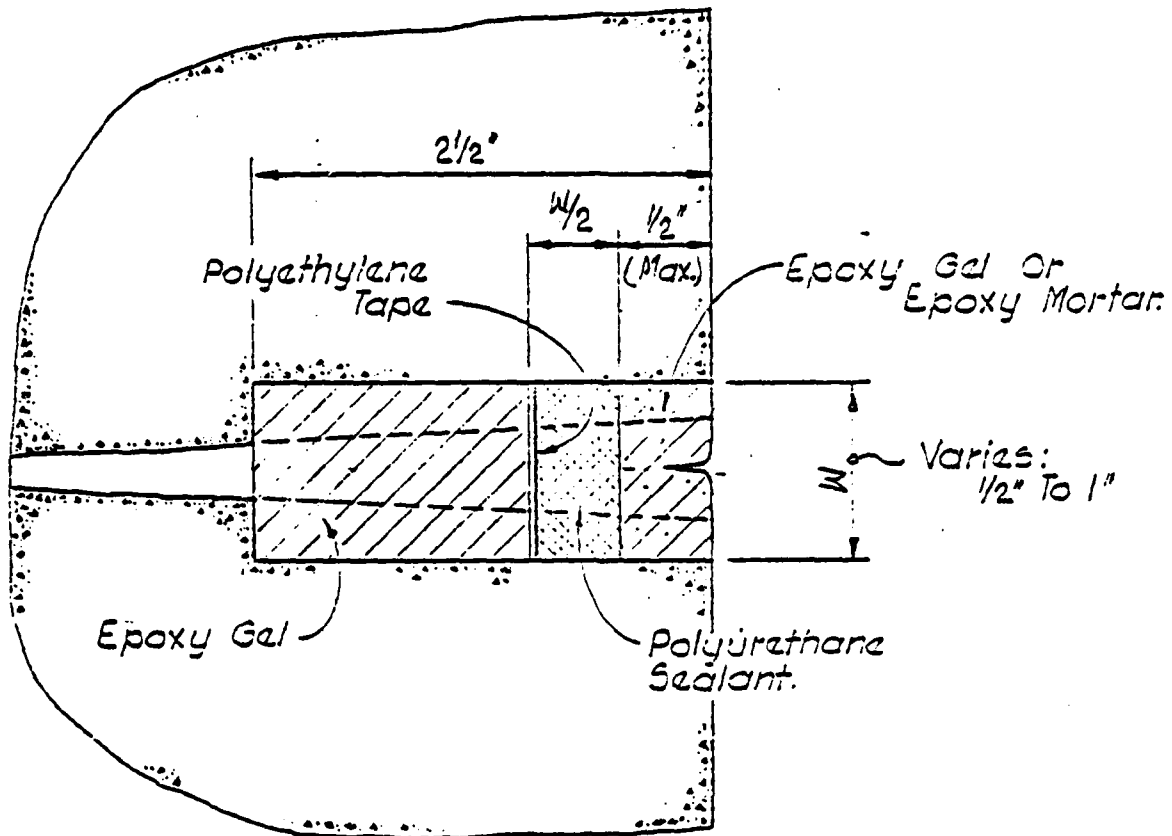
CRACK REPAIR

1. The average crack width is $3/8$ " to $1/2$ " with one crack being 1" wide.
2. The depth of the cracks are 3" to 4".
3. The cracks are subjected to a maximum back pressure of about 25 feet of water although none are leaking and only a little dampness is present in some.
4. It is assumed the cracks are working shrinkage cracks and they do not impair the adequacy of the structure.

Crack Repair
(Refer to enclosed sketch)

1. Using a saw tooth bit, widen the crack slightly ($1/2$ " minimum width) by cutting a trim, narrow, sharp edged groove to a depth of 2-1/2 inches.
